Icon Site Entrance – Underpass Lighting.

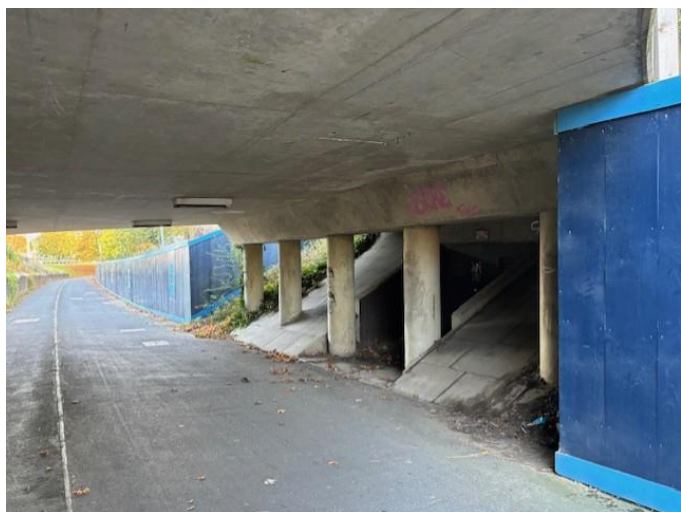
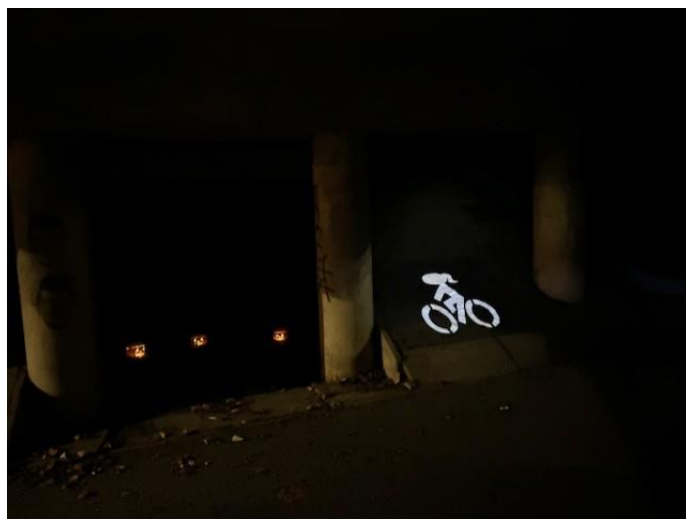
The lighting in this underpass appears to NOT be maintained by HCC – there are no yellow markers on their online fault reporting map as seen for the underpass under Lytton Way itself.

The photo below taken in daylight shows the lighting units that are not currently in use. It also shows the void on one side which is in complete darkness at night – as seen in the other picture where the reflective image laid out on the concrete slope is lit by torchlight.

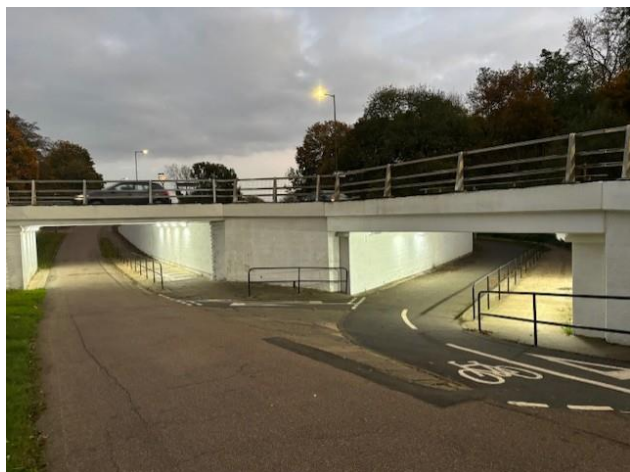
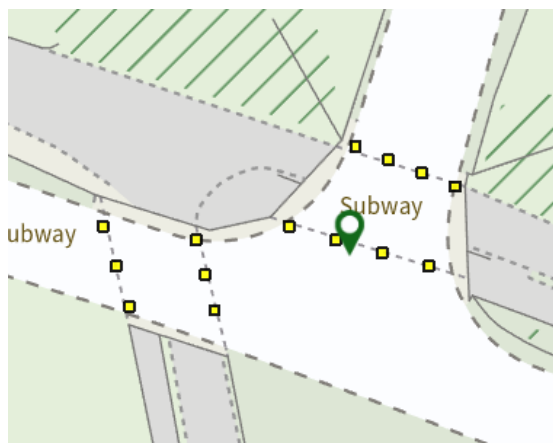
The photo below is typical of all the OTHER underpasses seen across Stevenage on the rest of the cycleway network. It is well lit with lights coming on at twilight as seen here. Lighting is maintained by HCC – all lamps on all other underpasses are indicated on their fault reporting map – relevant extract shown below.
