## THE NEW KENT ROAD CYCLE TRACK (LONDON CYCLE NETWORK ROUTE LCN23) DESIGN FLAWS AND INCONSISTENCIES IN THE CYCLE TRACK SIGNING

### Briefing in support of Kristian Gregory's defence against his fine and/or prosecution for pavement cycling

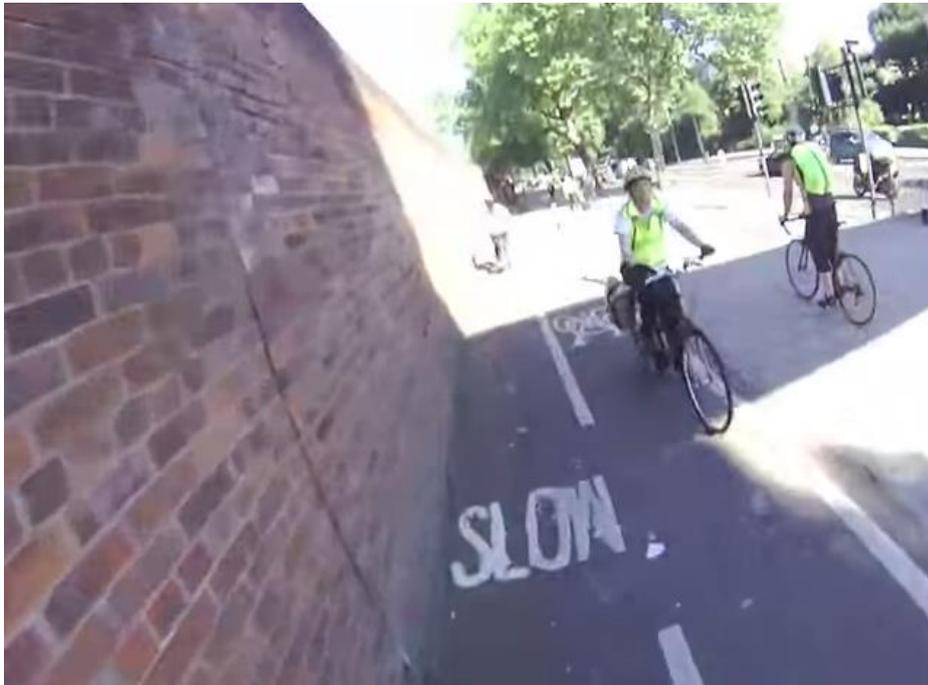
Photo 1 is taken from Kristian Gregory's helmet-camera footage of the lead-up to the moment when he was stopped and fined<sup>1</sup>. It shows him sticking to the cycle track, despite the limited width available to pass an oncoming cyclist. The cyclist to the right of the photo has already pulled out of the cycle track to overtake the slower cyclist in front of Mr Gregory.

Photo 1: conflict due to the cycle track's limited width

It will be noted that the cycle track is around 2 metres wide. Guidance on cycle track design from both the Department for Transport and from Transport for London suggests that a cycle track intended for two-way cycle-use should be at least 3m wide, with an additional 0.5m needed if the track is bounded by a wall. The Department for Transport's Local Transport Note LTN 1/12, 'Shared use routes for pedestrians and cyclists'<sup>2</sup>, says that, "*The preferred minimum effective width for a two-way cycle track is 3 metres. These effective widths will need additional clearance where track edge constraints such as kerbs or walls are present (see Table 7.4).*" Table 7.4 indicates that 0.5m of extra width is needed adjacent to a vertical feature (e.g. a wall) more than 60cm high.

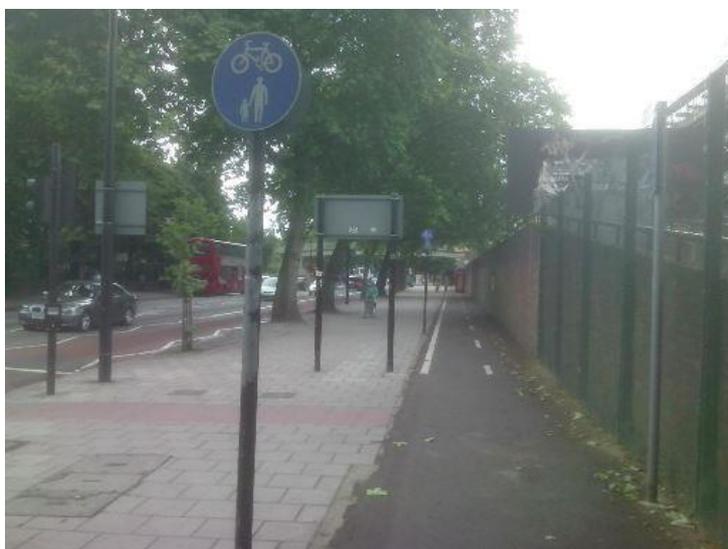
Photo 2 shows the location looking eastbound, i.e. the opposite direction to that in which Mr Gregory was travelling. It shows traffic sign 956, indicating that the whole of the pavement adjacent to the pelican crossing constitutes a route for shared use by cycles and pedestrians.

Photo 2: looking eastbound. The first sign indicates a shared cycle/pedestrian area beside the pelican crossing.

In the background to photo 2 there is a second sign. Although unclear in this photo, it is a sign number 957, indicating that the cycle track has now become a segregated track, where cyclists are supposed to remain on one side of the solid white line (the right side, in this case).

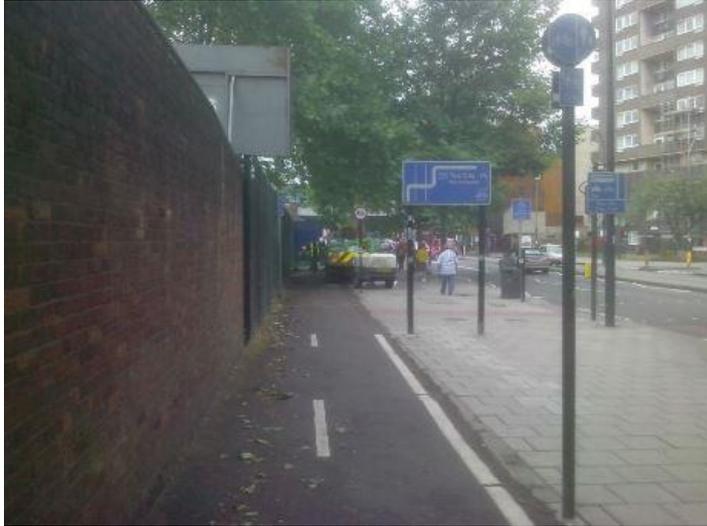
Photo 3 however shows this section of the pavement from the opposite direction. This shows that the sign on the reverse of the more distant sign in photo 1 indicates that the area between the two sign-posts is segregated, contrary to the first sign in photo 1.

Moreover there is no 'unsegregated shared use' sign (sign number 056) between this point and the pelican crossing, despite the direction sign indicating that cyclists are supposed to use the pelican crossing to cross the road. The next sign beyond this 'segregated cycle track' sign is an 'end of cycle route' sign (sign number 951).

Hence for cyclists travelling westbound (as Mr Gregory was doing), the direction signing is not accompanied by any indication of where it is legally permissible to pull over to the right hand side of the pavement to access the pelican crossing.

Photo 3: the same scene looking westbound. The nearest sign indicates that the area up to and beyond the pelican crossing (as far as the "no cycling" sign in the background) is a segregated track. This not only contradicts the sign in the foreground of photo 1, but also provides no indication of where cyclists may legally access the pelican crossing point, despite the direction signing urging them to do so.

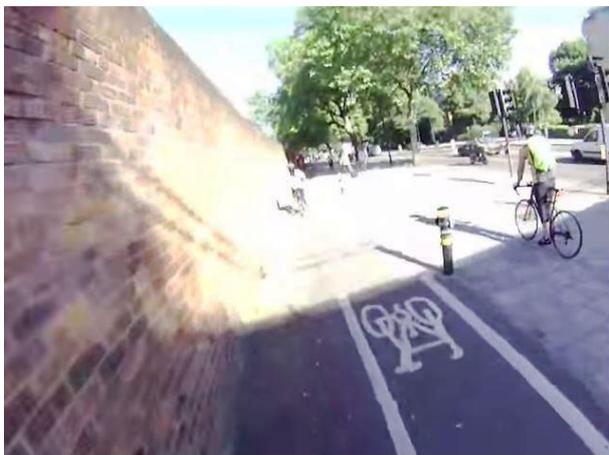
Photo 4: Start of unsegregated shared use area by first pelican crossing (from K Gregory video, 14 secs)

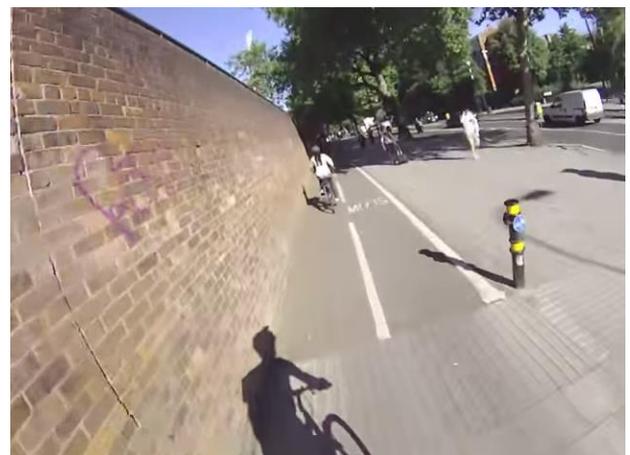
Photo 5: End of unsegregated shared use area by first pelican crossing (from K Gregory video, 16 secs)

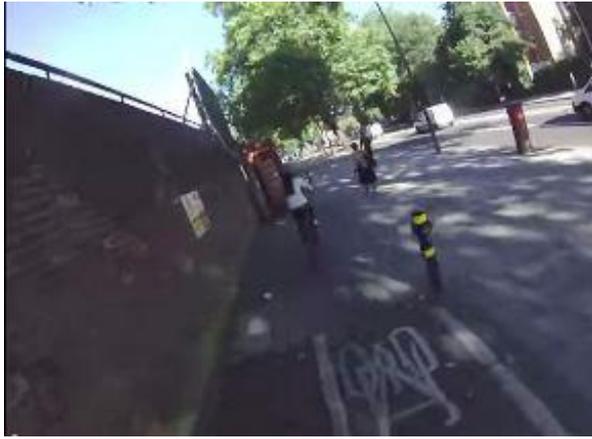
Photo 6: Start of unsegregated shared use area by phone box (from K Gregory video, 22 secs)

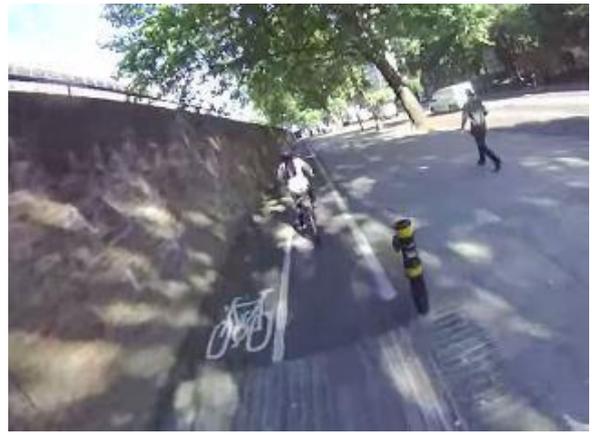
Photo 7: End of unsegregated shared use area by phone box (from K Gregory video, 25 secs)

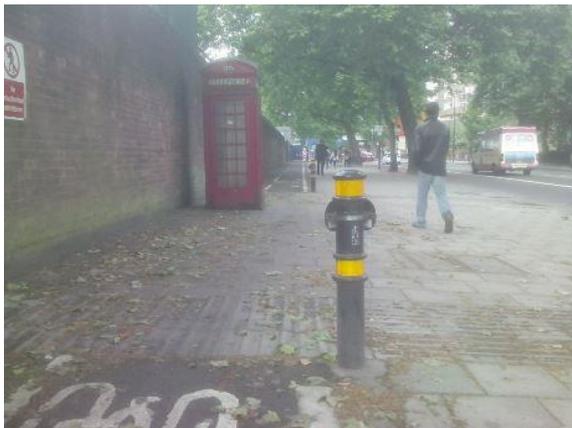
Photos 8 and 9 show close-ups of the signing on the bollard just before (i.e. to the east of) the phone box (i.e.. the one in the foreground of photo 6), looking westbound and eastbound respectively. They show that the signing on both bollards is facing the wrong way. Photo 8 shows that westbound cyclists are unable to see either the “unsegregated shared use” sign (which is presumably aimed at them), or the segregated shared use sign (which is presumably meant to face the other way). Photo 9 shows both signs being visible instead to eastbound cyclists.

Photo 8: Westbound view of bollard before (to the east of) the phone box.

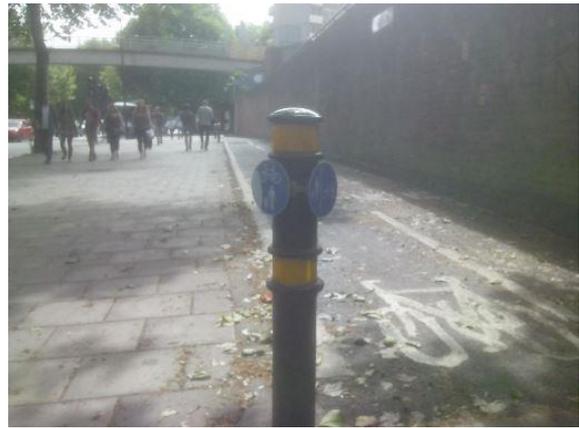
Photo 9: Eastbound view of bollard before (to the east of) the phone box

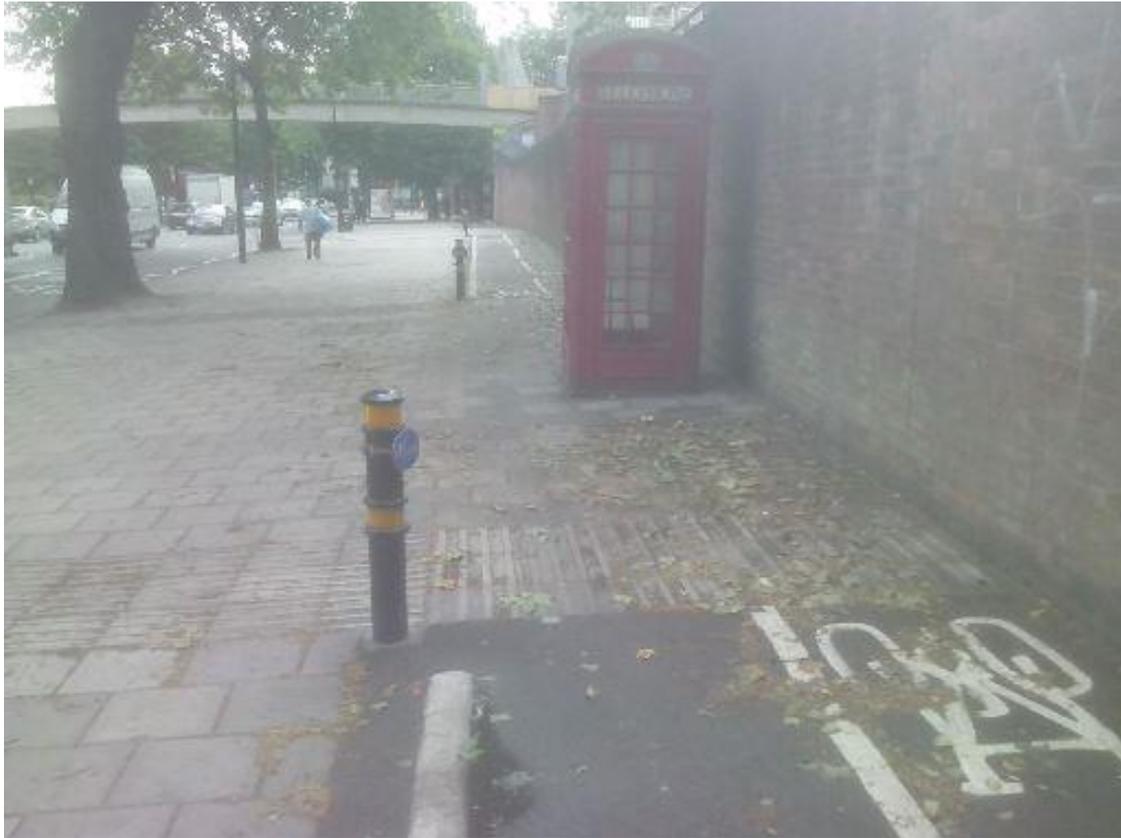
Photo 10 is a close-up of the bollard to the west of the phone-box, looking eastbound. It too is facing the wrong way, with the sign for a segregated cycle track being visible to eastbound cyclists (who are about to enter an unsegregated section), instead of to westbound cyclists such as Mr Gregory (to whom it is presumably intended to apply).

Moreover, if it was pointed to face westbound cyclists, it is clear that the sign is the wrong way round, showing the cycle track on the right and the pedestrian area on the left. In fact, for westbound cyclists, the cycle track is on the left (adjacent to the wall) and the pedestrian area on the right.

Photo 10: looking eastbound. The segregated use sign (which is presumably aimed at westbound cyclists) is facing the wrong way, but also has the cycle track and the pedestrian area shown the wrong way round.
