Icon Site Entrance – Underpass Lighting.

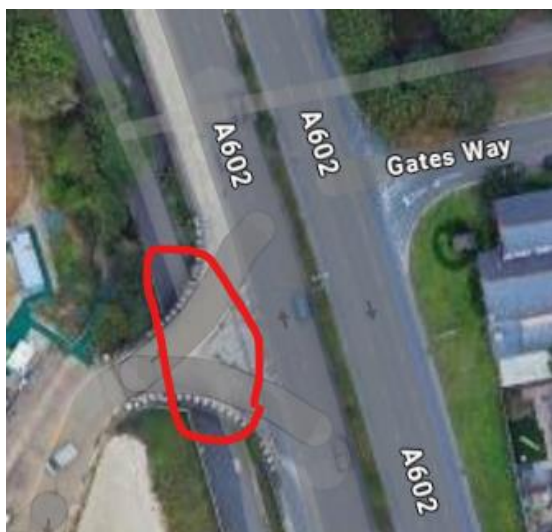
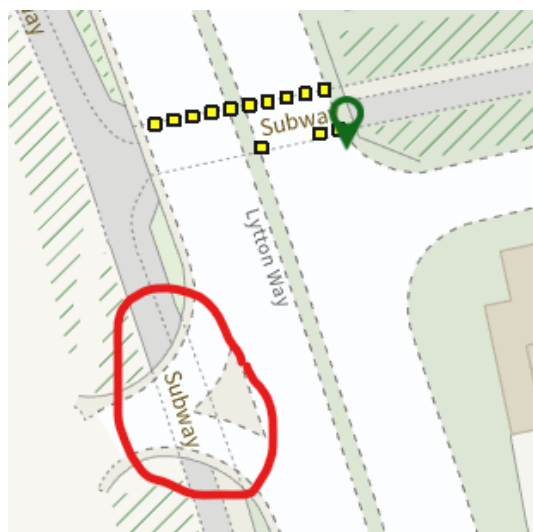
This map shows the location of the dark underpass under the Icon site entrance.

The lighting in this underpass appears to NOT be maintained by HCC – there are no yellow markers on their online fault reporting map as seen for the underpass under Lytton Way itself.
