Radfahren July '92

Fly, biker, fly

Darned Mudguard

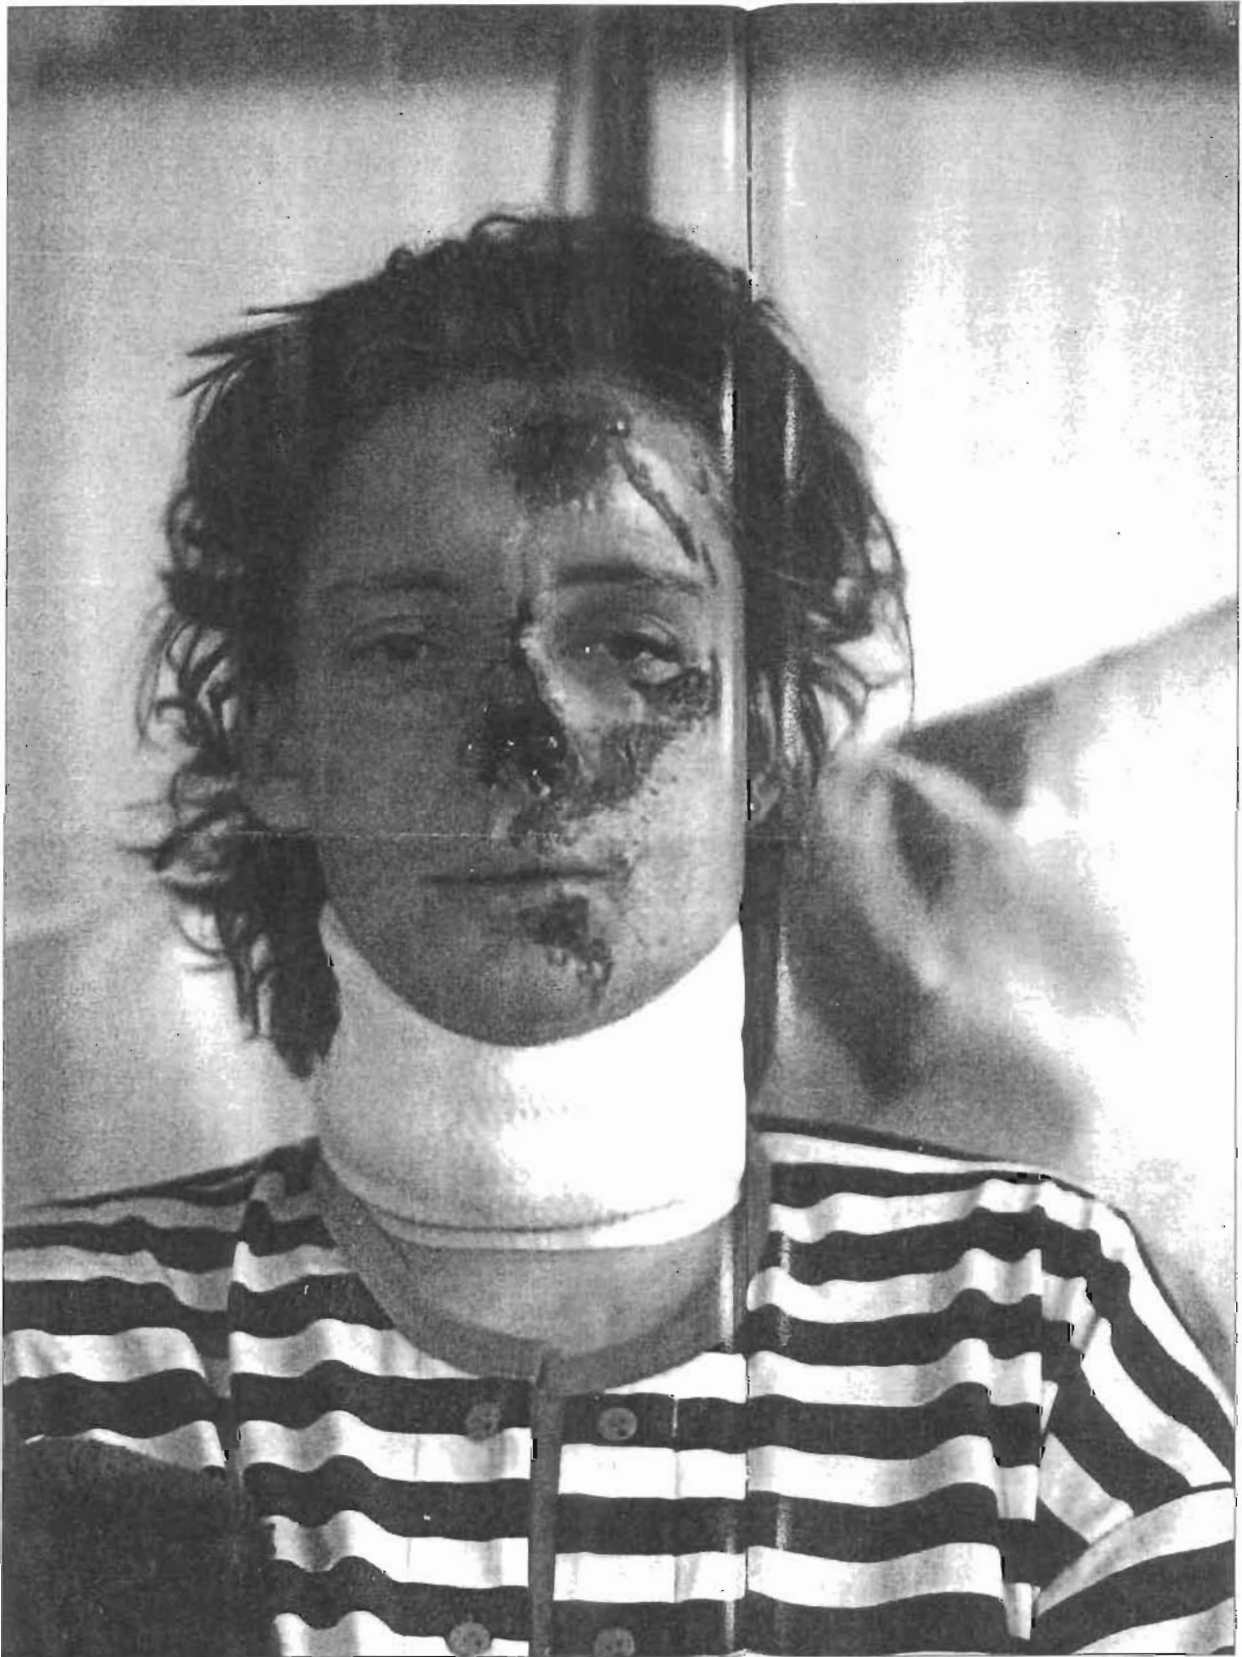
During the last two years 5 friends, including one of the authors, had to suffer brutally from such a negative event, some of them even incurred severe injuries (see photo 1); material damage amounted to some DM 1,000 (frame, fork, etc).

In most cases these accidents were caused by objects (pebbles, small branches) getting caught between front wheel and mudguards or between the spokes. As a result the mudguard started to fold up, was drawn upwards under the forkbridge and in split seconds exercised its harmful blocking power.
